Assessing the Downstream Impacts of Soil Sedimentation Caused by Small-Scale Alluvial Mining in Atamo, Central Bougainville

A Rodney Biri^{1*}, B Alois Ndrewou², C Hefung Hati¹ and D Eric Mesimato¹

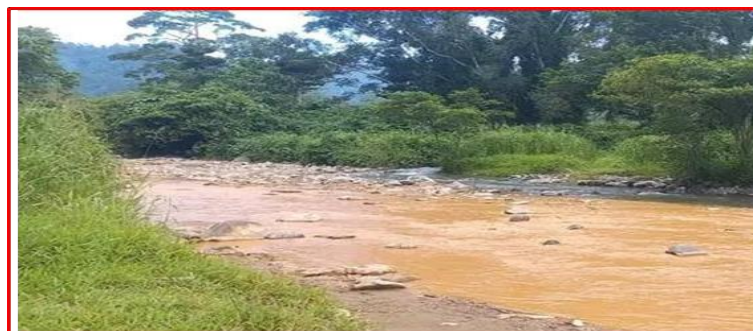
Figure 3. A river showing highly turbid and dirty water, affected by soil sedimentation residue from mining activities

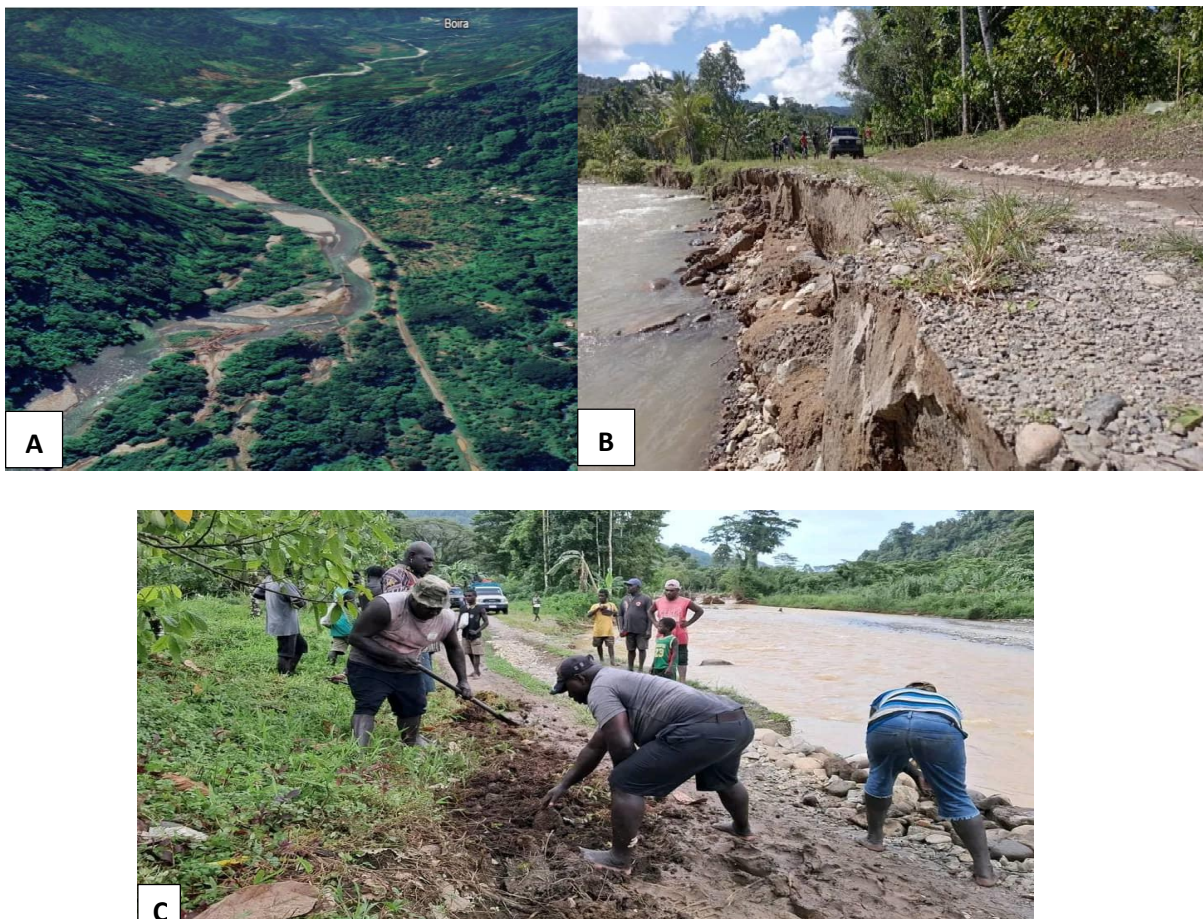
Figure 4. a) Ariel View of disrupted water flow pattern; b) Road affected due to water flow disturbance; c) Road affected due to sedimentation

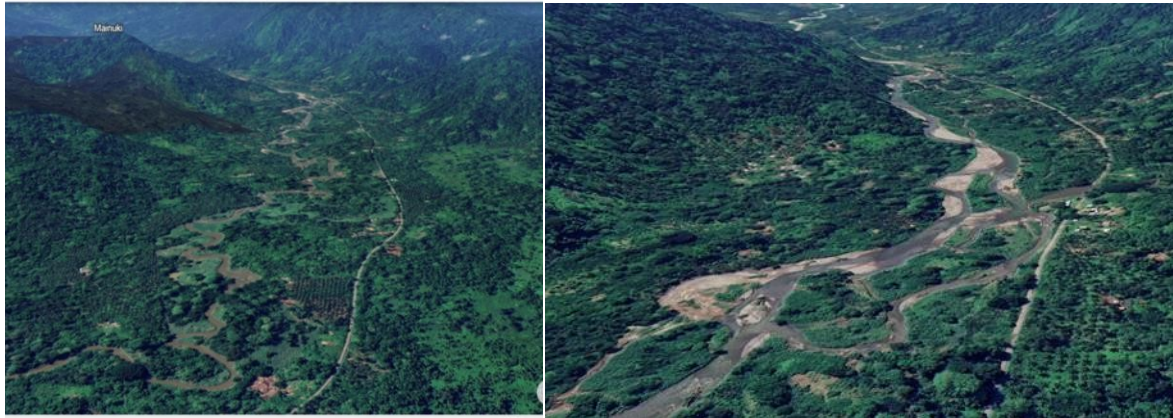
Figure 5. River flow pattern disrupts by continuous soil accumulation at bottom
